## **Demorest Woman's Club Economic Feasibility Study**

**2015**

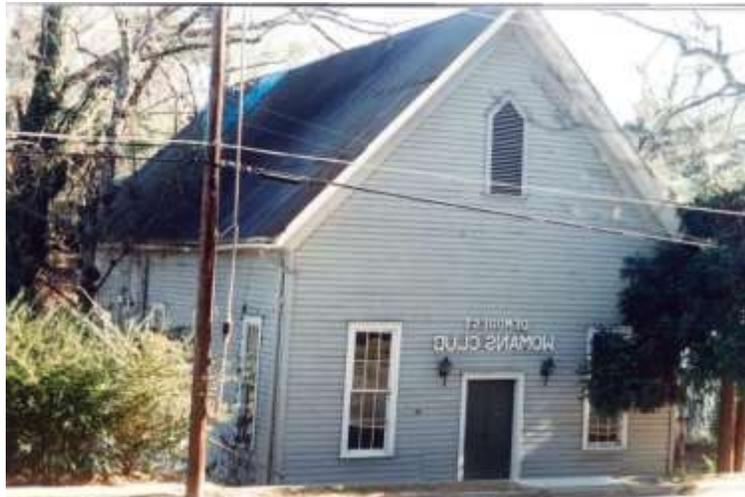
**Figure 9. Demorest Woman's Club in 1995 before roof repairs were made and showing side front window that is no longer present and should be reinstalled.**

The exterior of the building originally featured a steeple at the front left corner, a historic wood double sash window below and an open area below the main level (Fig. 1). The steeple was removed when it became the woman's club and the lower level and window were filled in as well. It is recommended that the historic window be reinstalled in this corner to restore symmetry to the building (Fig. 9.).

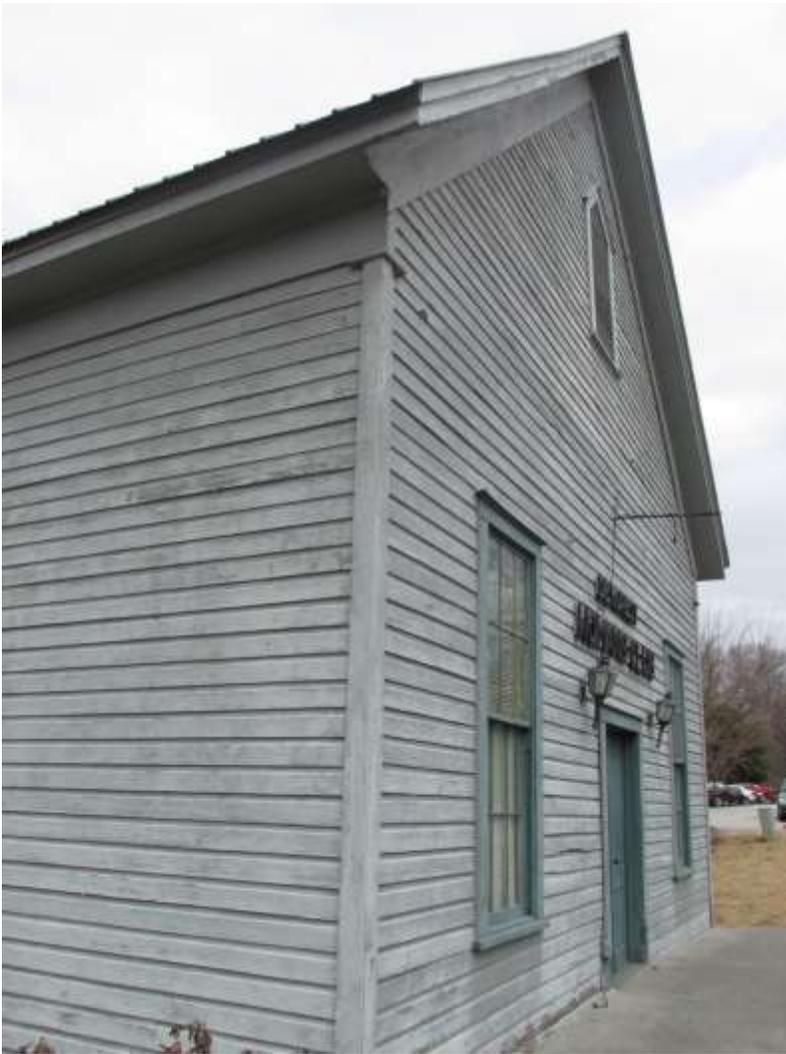
**Figure 15. Front of building. Overall, the main floor's siding is in good condition but needs to be painted. The front left of the building once had a window here and the opening should be restored with a similarly styled historic window.**

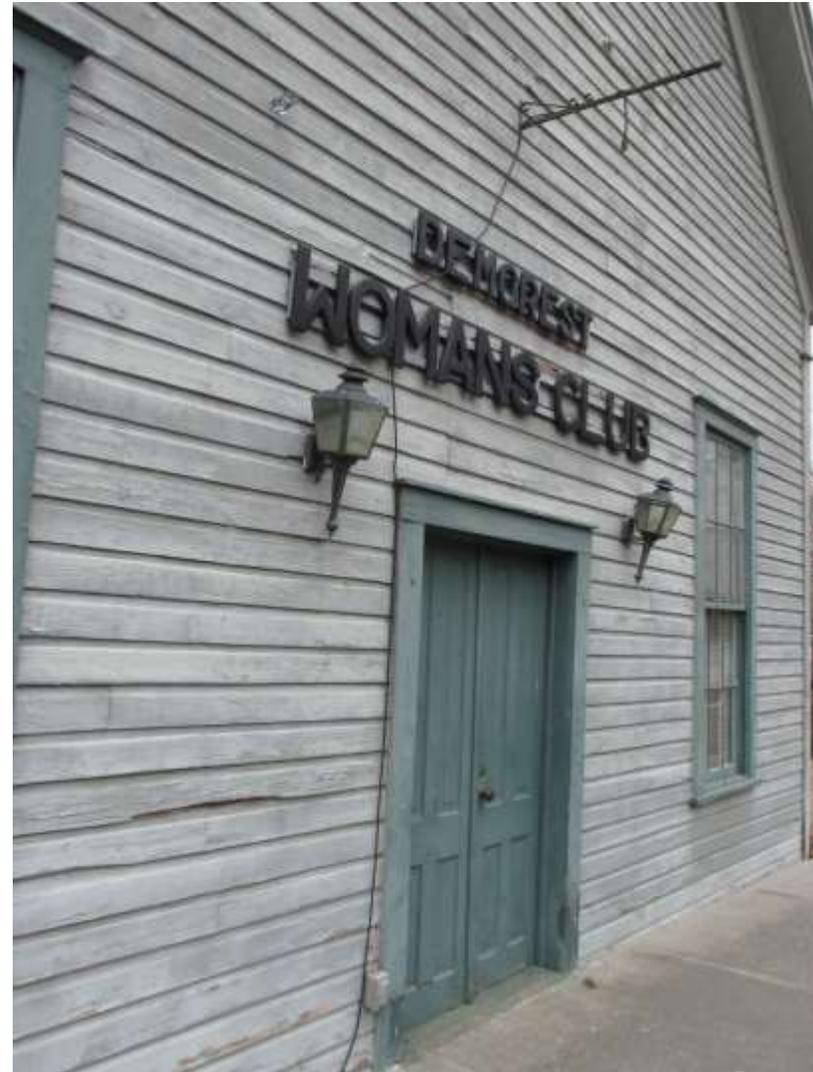
**Figure 16. The front entrance should be improved to offer better ADA accessibility.**

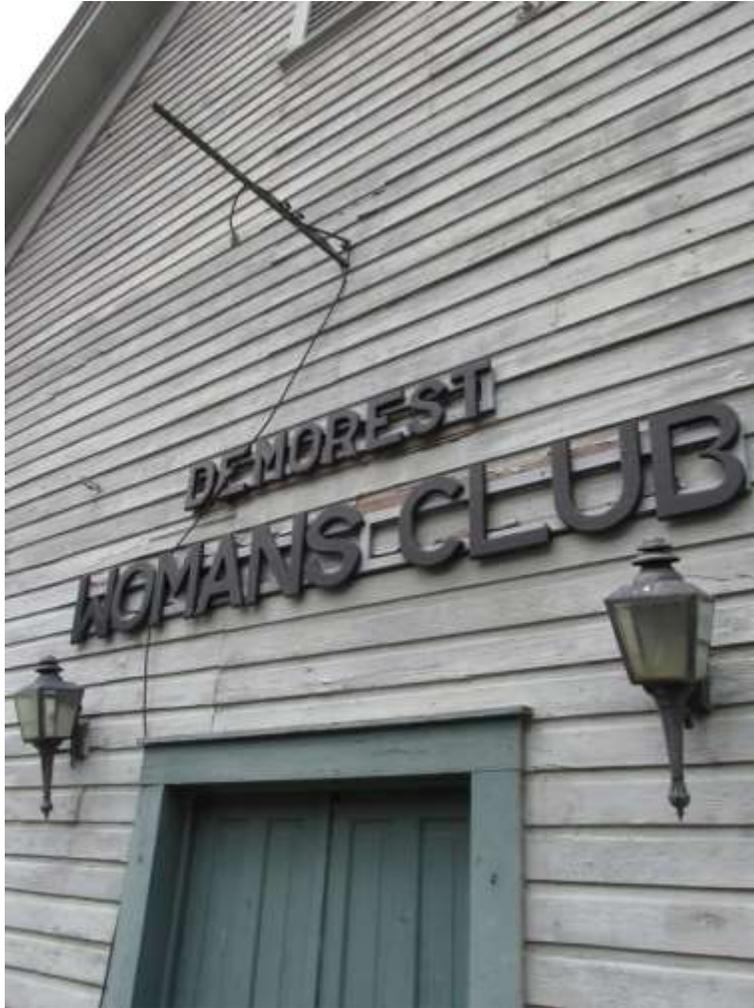
**Figure 17.** The current sign for the woman’s club has been here for many years and a new sign is recommended to prevent further wood deterioration behind the letters. A hanging sign or one fixed to the building would be appropriate and a goose neck light or other style above would offer plenty of light. The two lights flanking the door should also be updated to a more historically appropriate style.

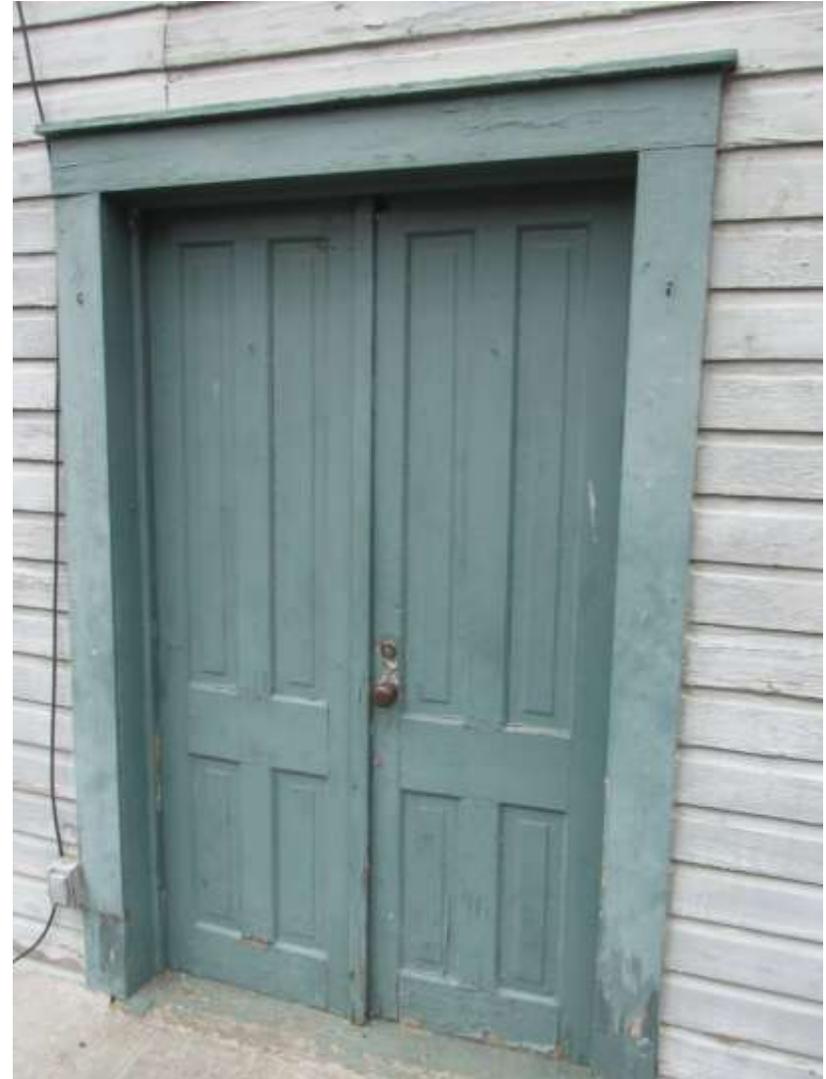
**Figure 18.** The front double door is original to the building but to ensure easy access for ADA accessibility, a new single door with side lights is recommended that would facilitate better access to the interior.

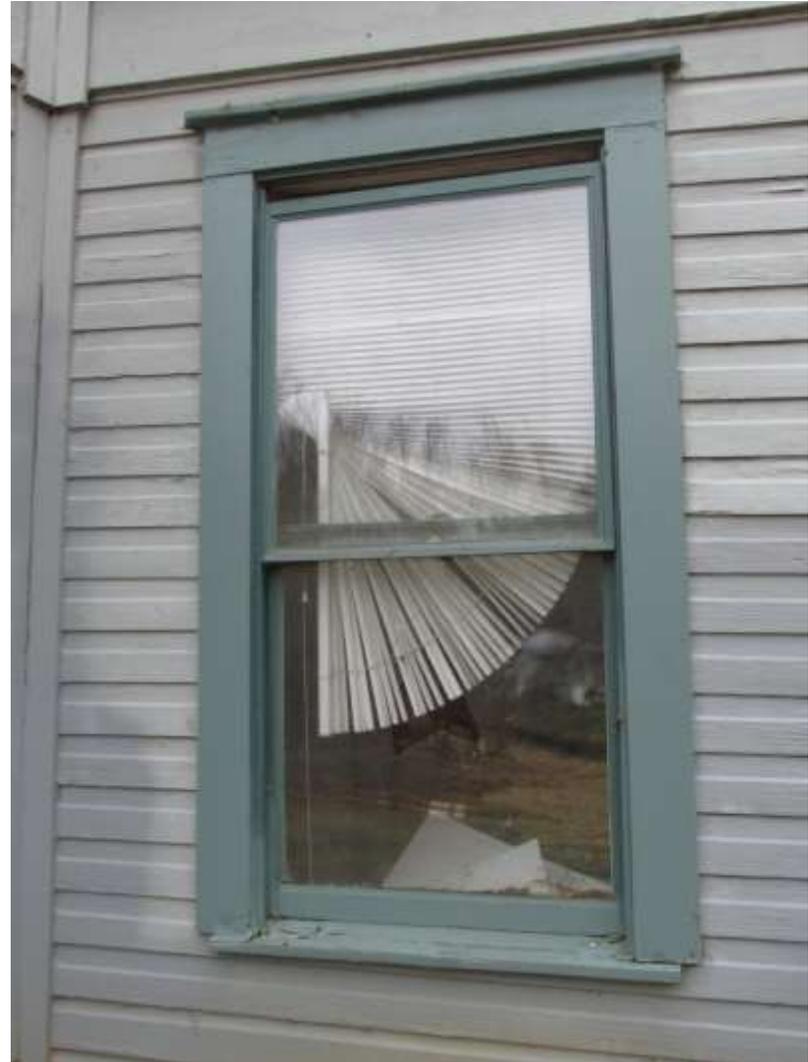
**Figure 32. Right side of building, north elevation with detail view of modern window sash on the lower level that is sagging at the top and the trim and sill do not line up at the bottom. September 2015.**

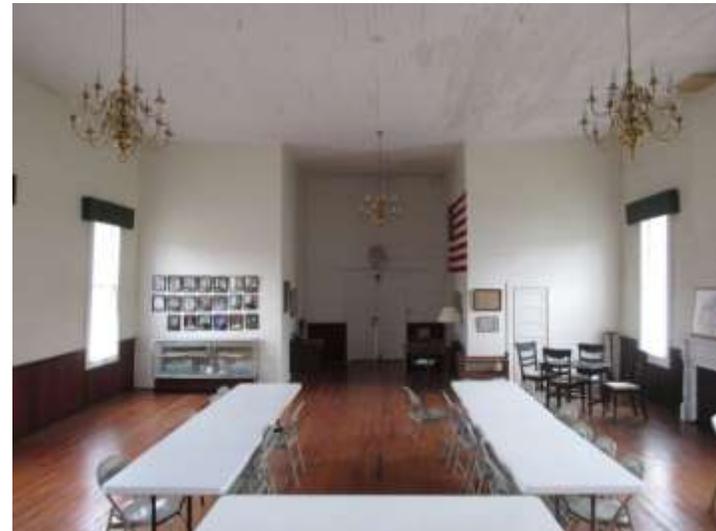
**Figure 34. Main floor looking towards the front doors, kitchen on left and stairs on right. It is recommended that the current chandeliers in the building be replaced with more period appropriate lighting.**

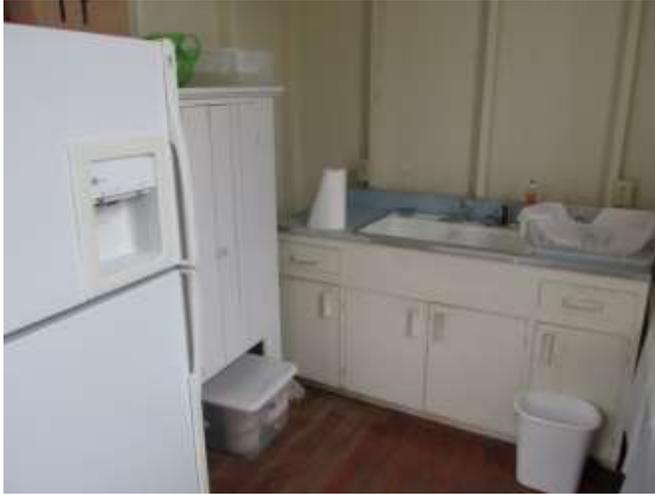
**Figure 37. Main Floor Kitchen. This area should be reconfigured into two (2) ADA accessible restrooms and utilize less floor space.**

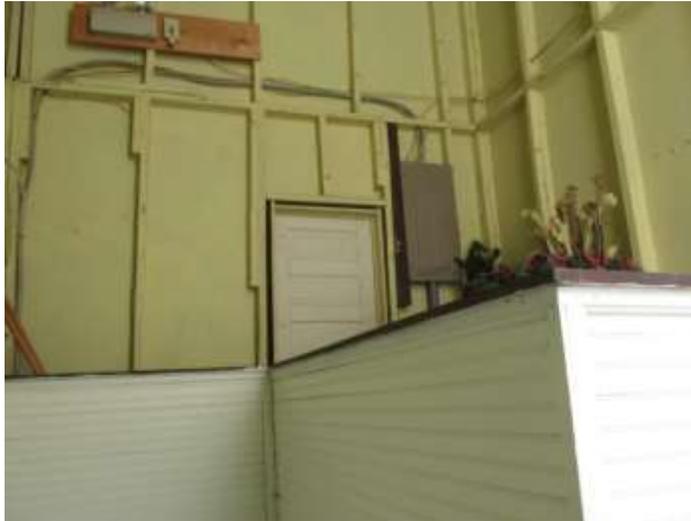
**Figure 38. Stairs to lower level. This area was originally open and should be restored to open floor space.**

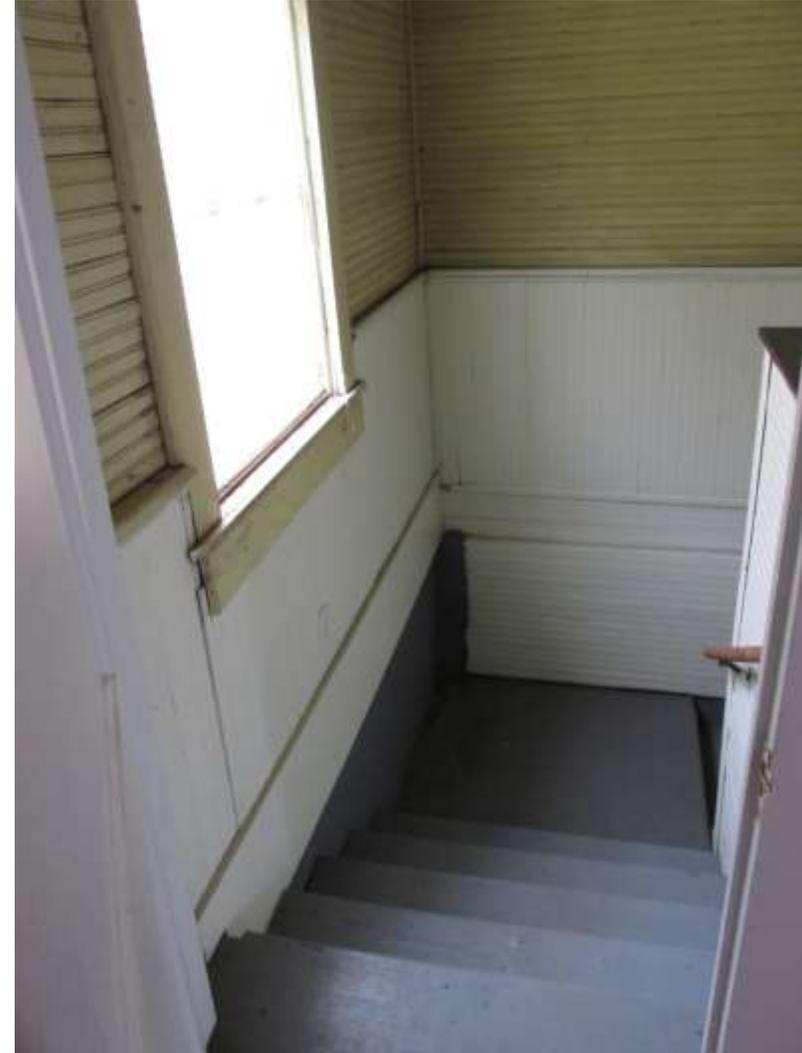
**Figure 39. Stairs to lower level. A window originally was located on the side wall. It was removed when the floor was opened to provide stair access to the lower level. It is recommended that the window opening be restored and the stairs relocated to allow for more floor space.**

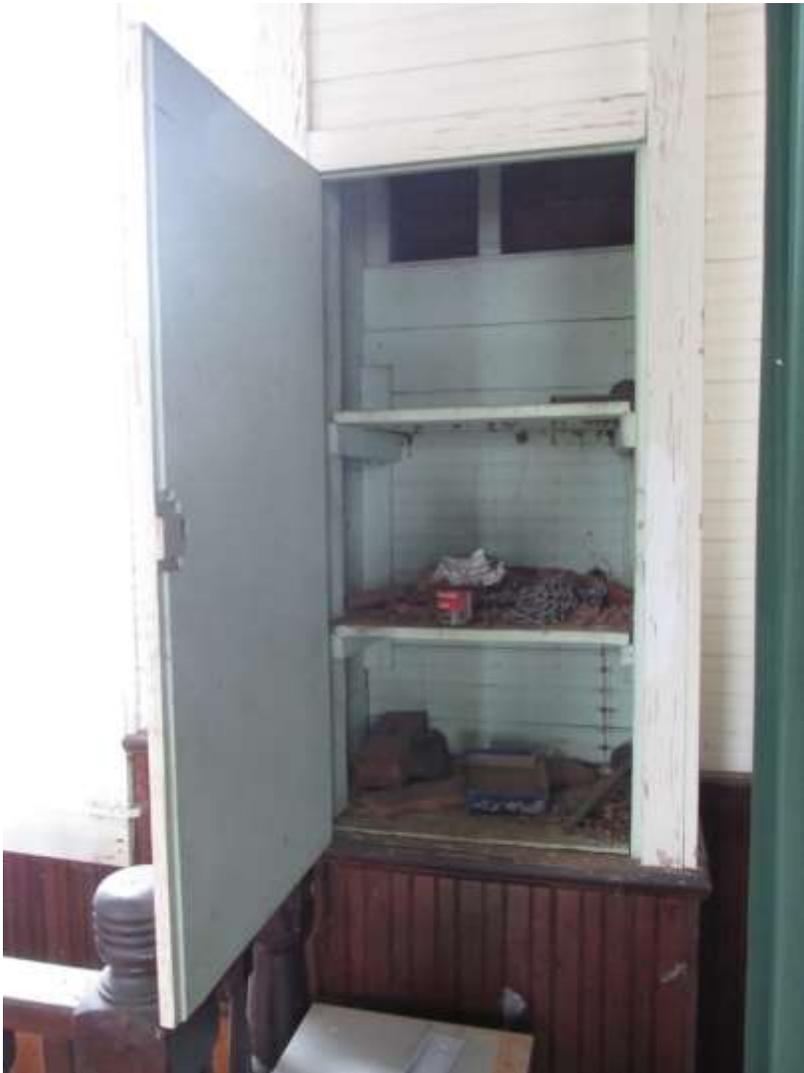
**Figure 29. Chimney system to the left of the stage stairs. This should be removed to allow for more stage area.**

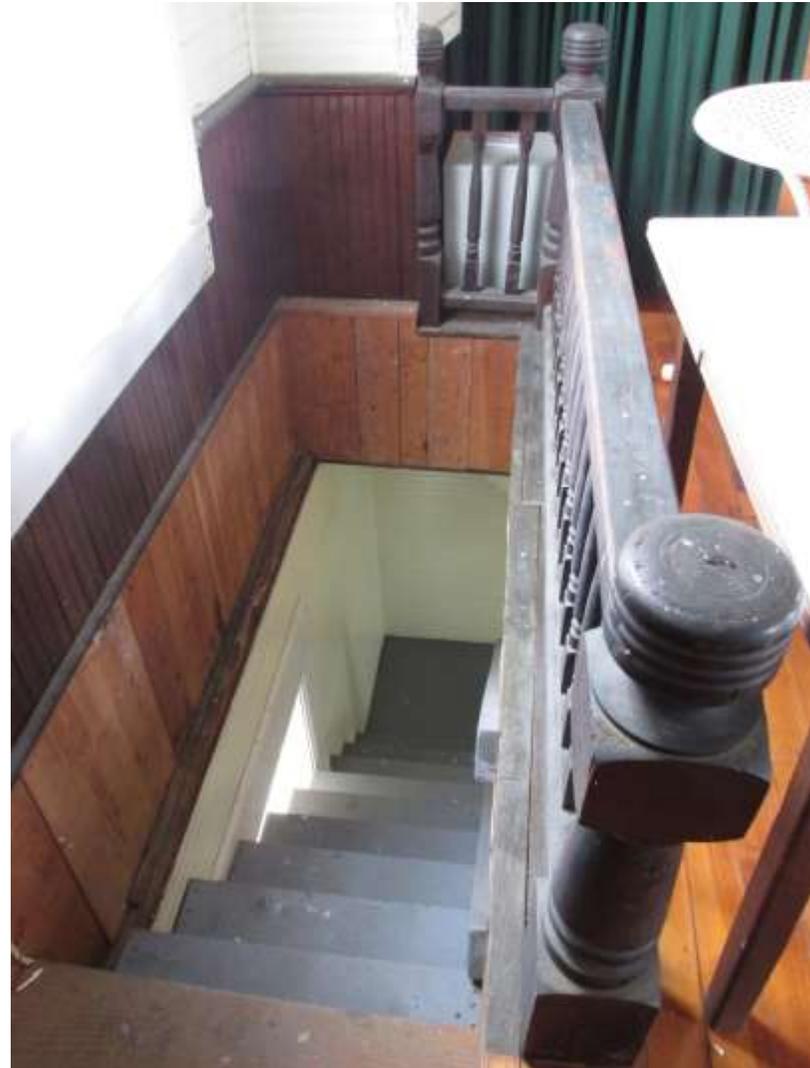
**Figure 30. Stage area on main floor looking towards stairs to lower level. These stairs should be removed and the opening utilized for a dumbwaiter food delivery system from the proposed catering kitchen below.**

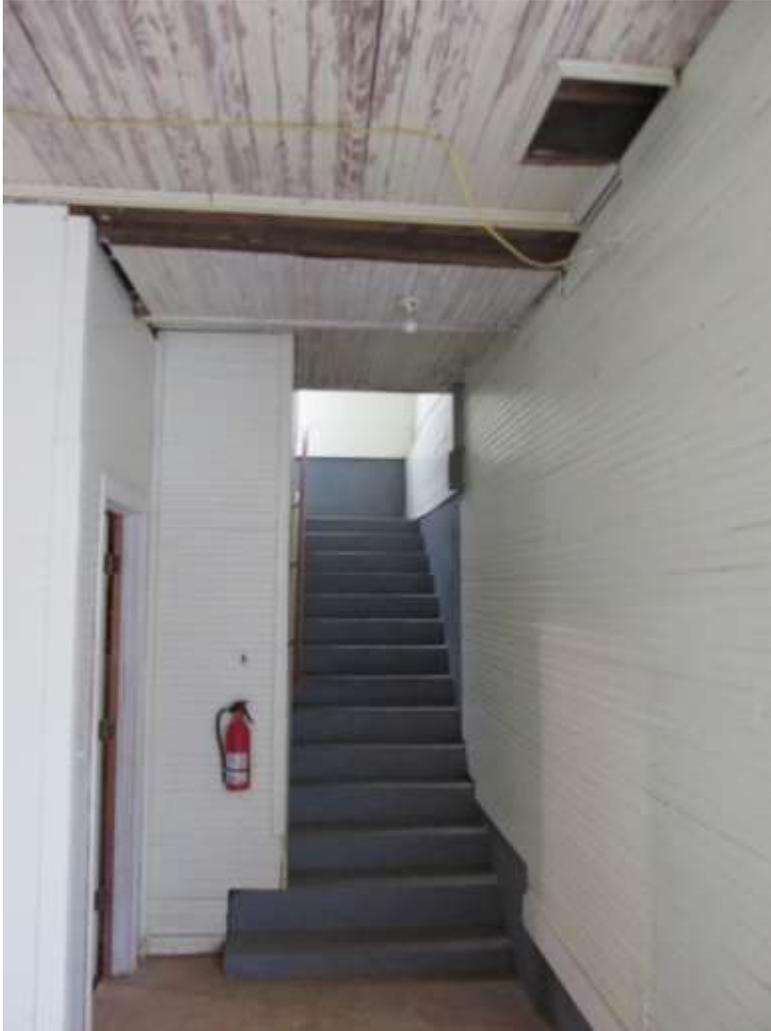
**Figure 36. The current stairs are recommended to be sealed off and the floor above restored for more floor space. This would allow this area to be utilized as an office for the Building Manager. The doorway to the left of the stairs leads to the mechanical room. This room would be accessed from the Building Manager's office after the project is complete.**

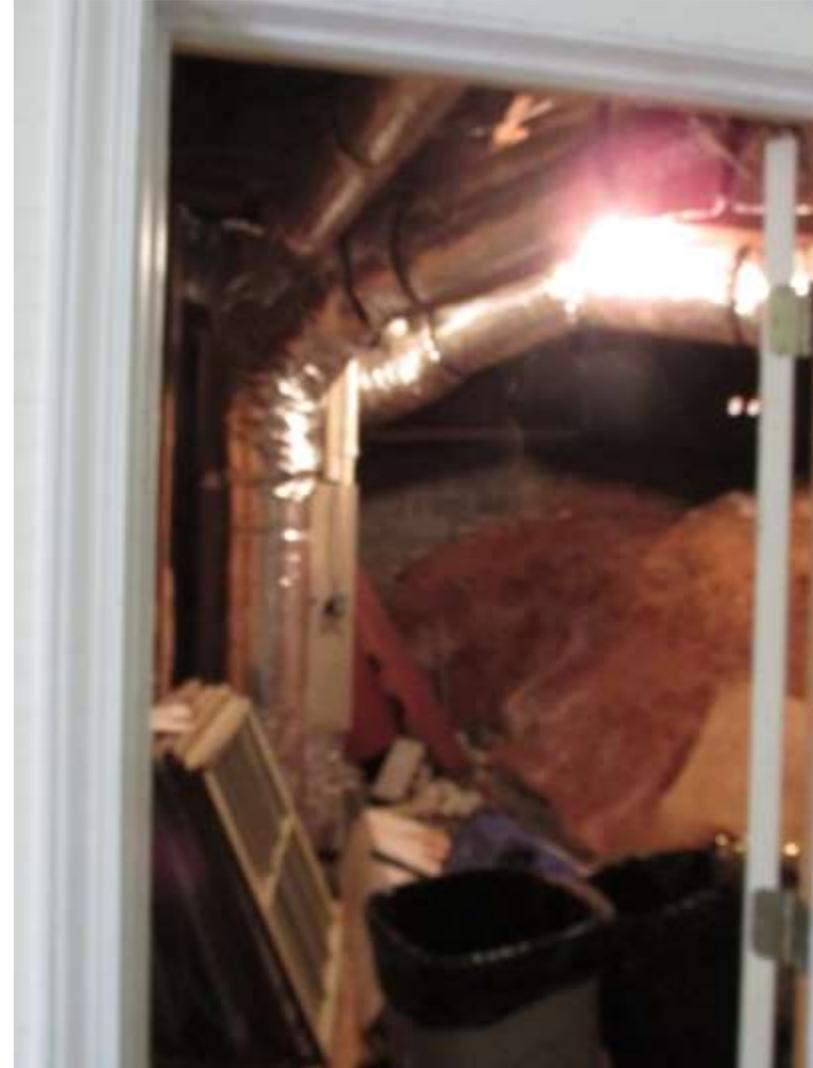
**Figure 37. At minimum this area should have a new concrete floor poured and a moisture barrier placed over the exposed clay earth. Improvements in this room would also allow for better storage space.**

Finally, since the current stairway will be encapsulated and the flooring above restored, this doorway should be closed off and the current mechanical room improved as budget permits. This should include a new concrete floor and vapor/moisture barriers of the exposed earth. .

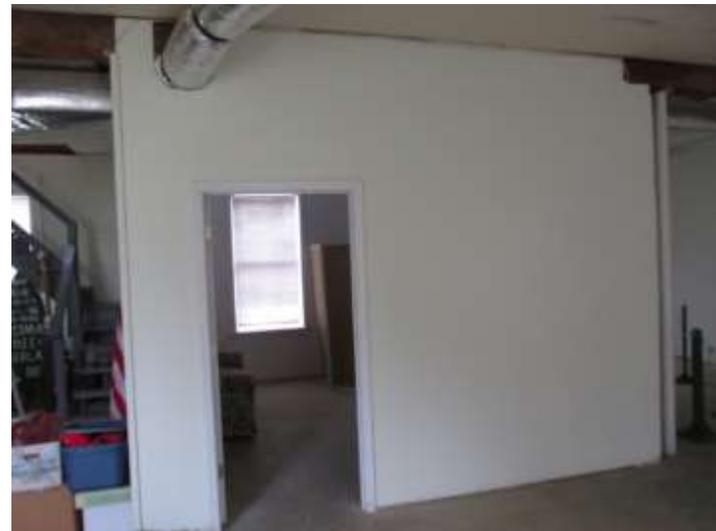
**Figure 40. Current lower level restroom. The restroom should be relocated to the bay window area on this floor and this area used as part of the proposed event room.**

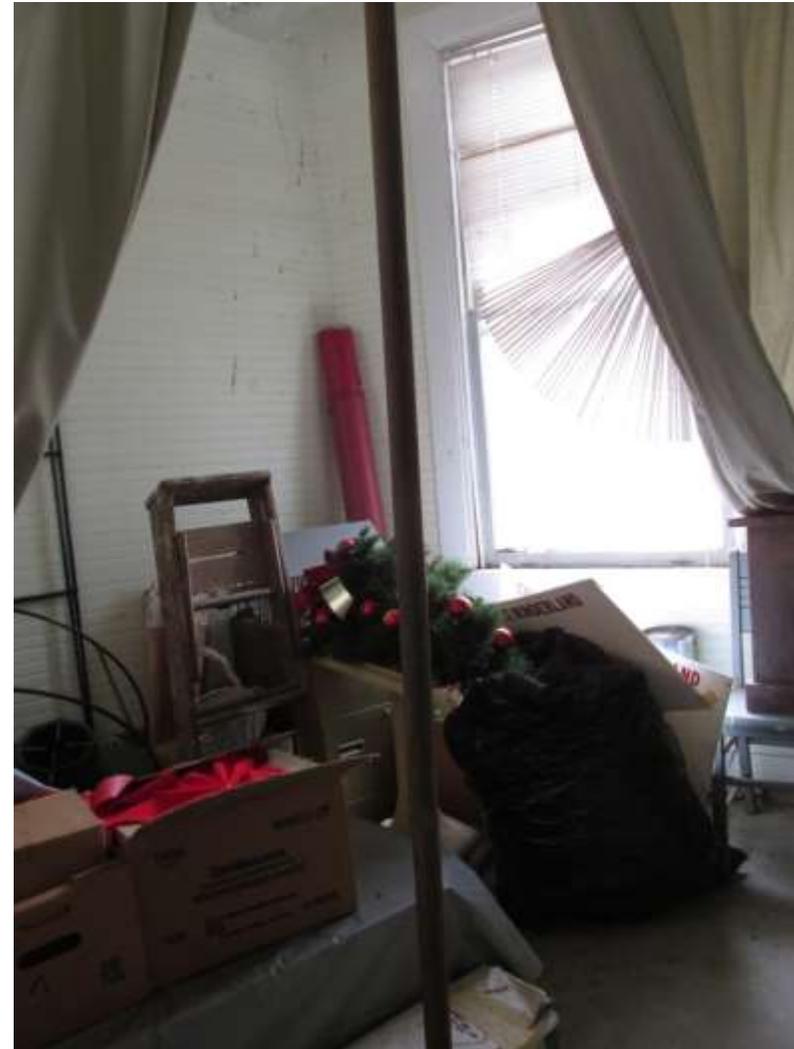
**Figure 43.** Lower level of the bay window area currently used as storage and should be renovated into staff restrooms.
