## **Demorest Woman's Club Economic Feasibility Study**

**2015**

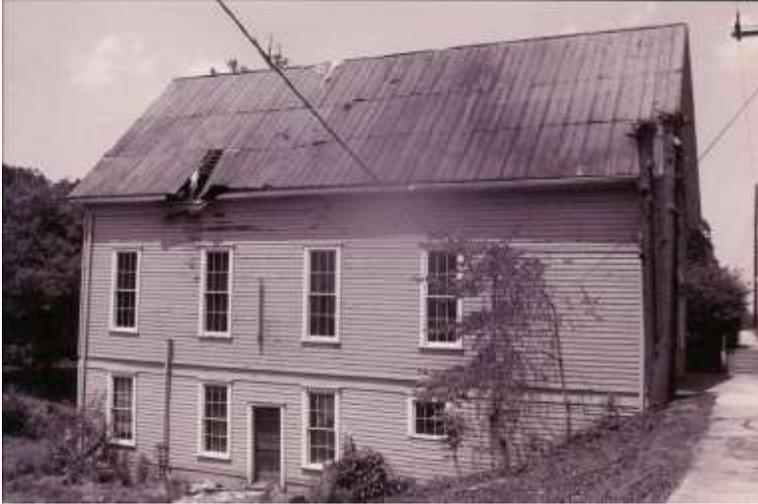
**Figure 5. Demorest Woman's Club in 1995 before roof repairs were made and exterior alterations were made to the lower level windows and doorway.**

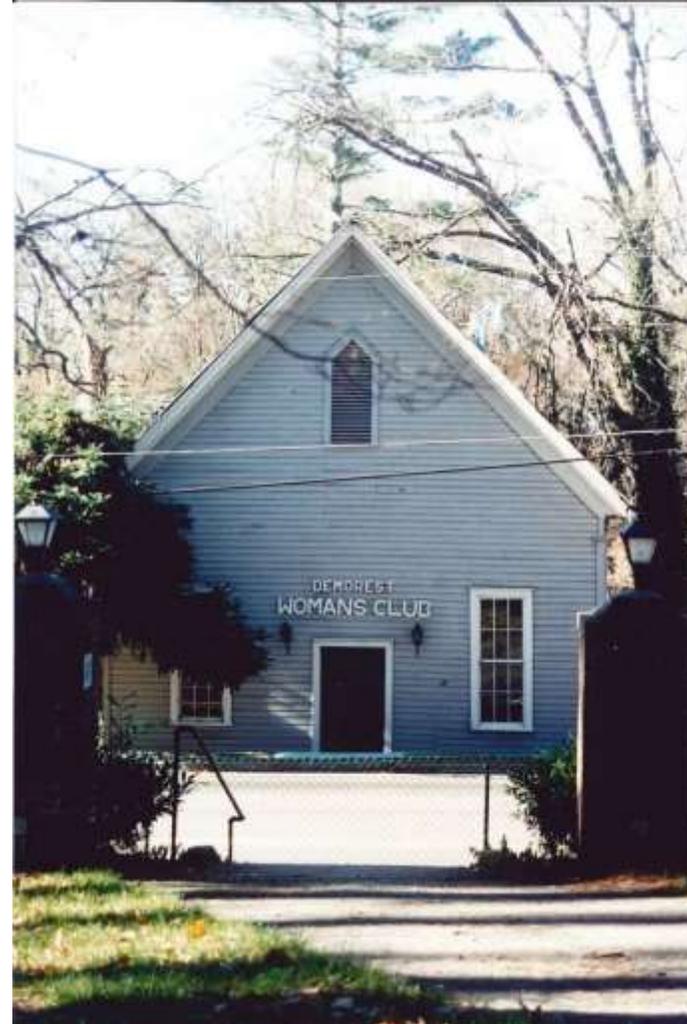
**Figure 10. Demorest Woman's Club in 1995 from Piedmont College.**

The original section of the building is in adequate condition. The wood clapboards do not show many signs of rot or repair needs. This section however should be repainted as soon as possible and photos from 1995 show the building as light blue (Fig. 9-10). The original standing seam metal roof was replaced at this time and the roof is still in great shape with no areas requiring immediate attention. The front door is original and is seen in Figure 2 and requires repairs. Currently the grade at the doorway is adequate but to prevent ADA accessibility issues a new historically compatible door is recommended.

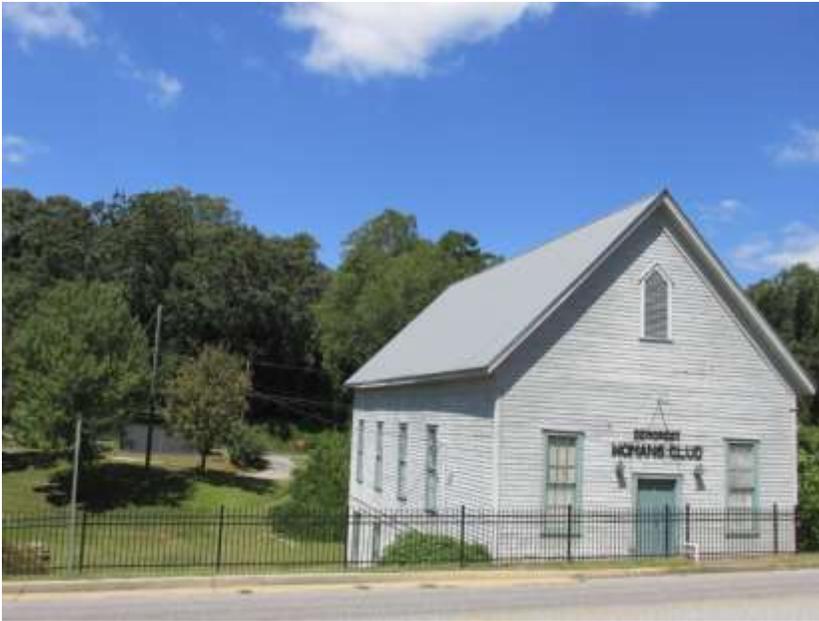
**Figure 11. View of the Demorest Woman's Club in September 2015. North Havel Avenue is directly behind the building and the turnoff to Piedmont College's parking lot could be extended to the side of the building. This would allow direct access to the building from the lower level and allow the proposed caterer's kitchen on this level to function for events.**

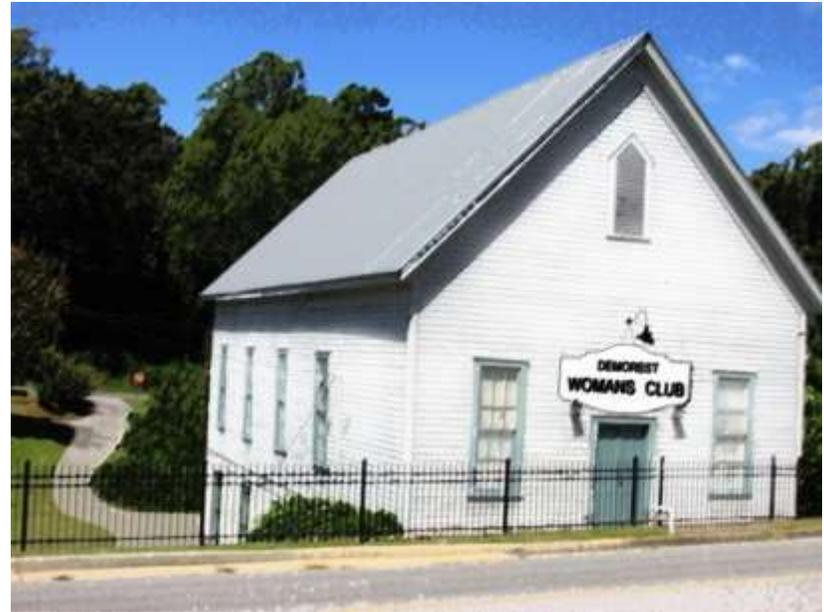
**Figure 12. Rendering of road connection to North Hazell Avenue to the building allowing deliveries below and an updated sign on the front of the building with new lighting.**

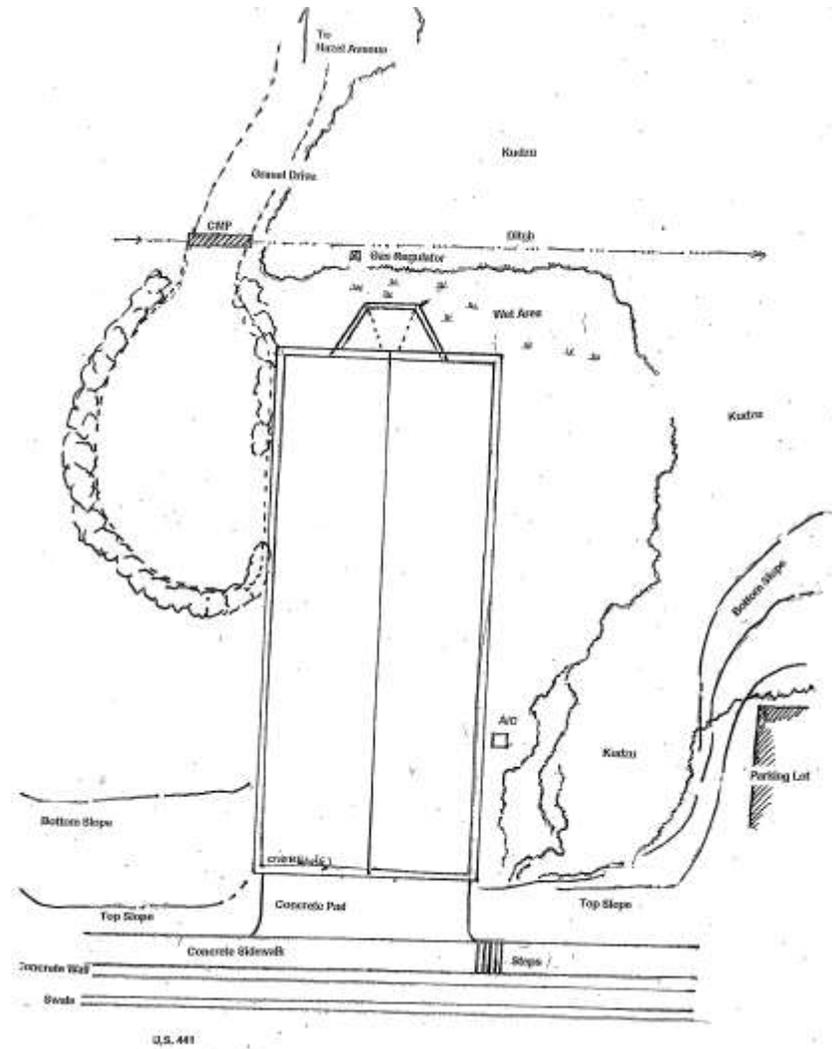
Figure 14. Suggested spur from this road to provide delivery and catering access to the lower level of the building.

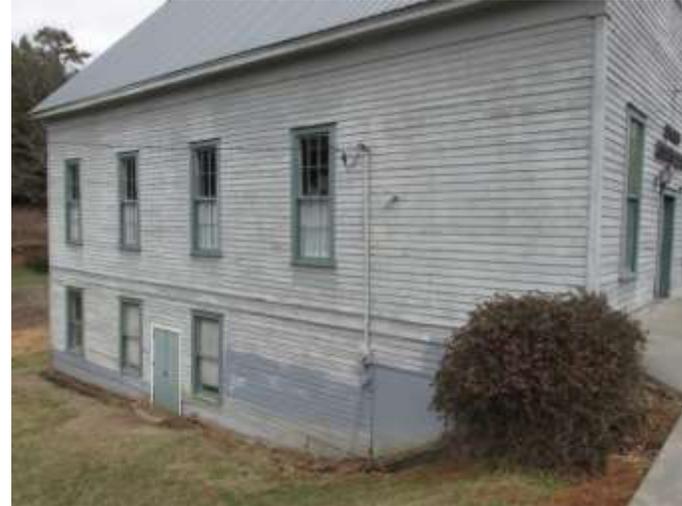
Figure 24. Left side of building, south elevation. This area can be utilized for a delivery area to the lower level catering kitchen and outdoor seating or garden space. September 2015.

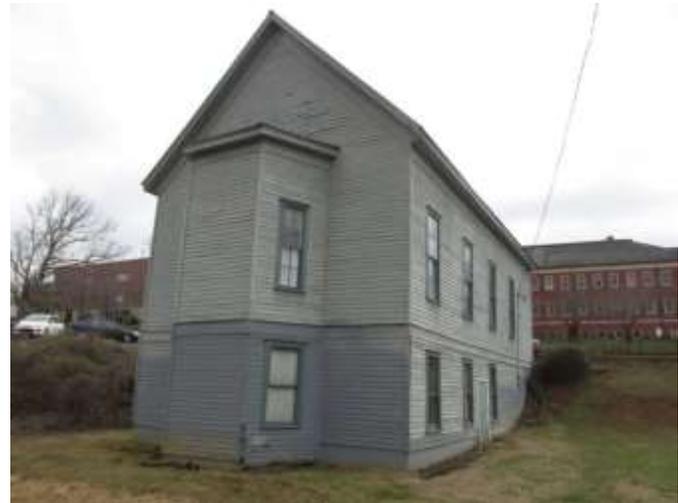
**Figure 29. Rear of building, west elevation. This area can be utilized for a delivery area to the lower level catering kitchen. September 2015.**

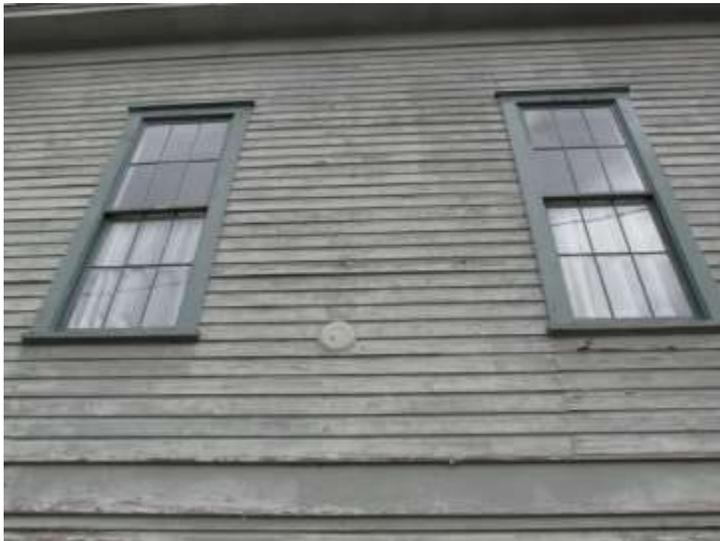
**Figure 31. Left side of building, south elevation, with detail view of historic windows on main floor. September 2015.**

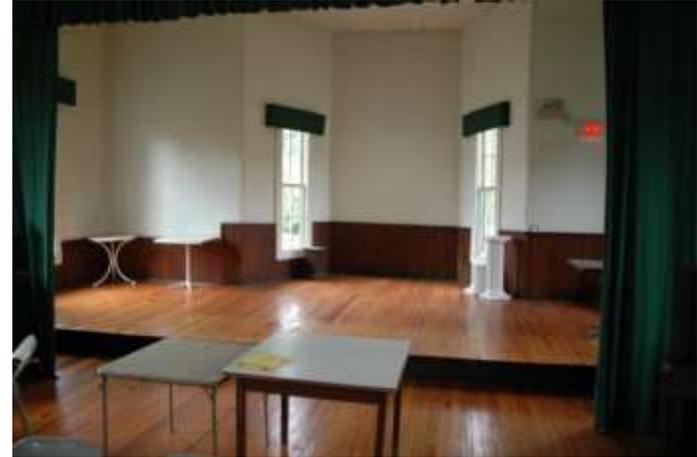
**Figure 32. Stage area on the main floor. A new set of stairs is proposed at the left to provide access to the downstairs area. The current stairs are on the right and these are recommended to be replaced with a dumbwaiter. The stage area also should be upgraded with a new stage curtain and other amenities as the project continues.**

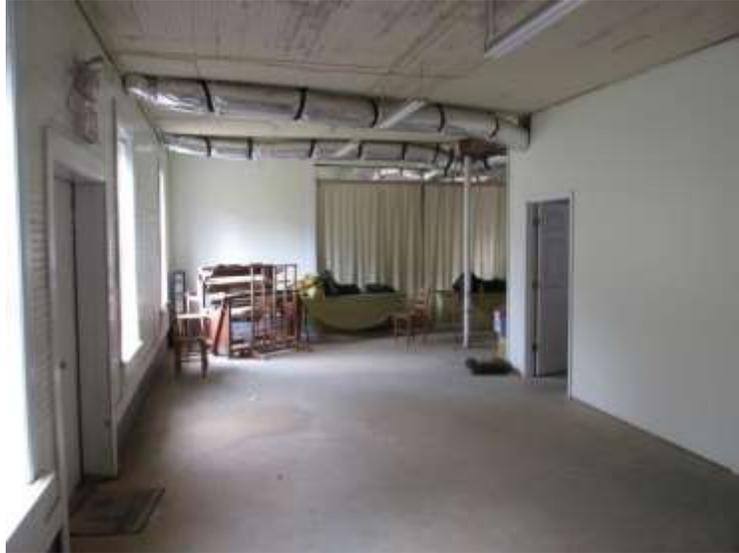
**Figure 34. Lower level looking towards the rear of the building. The doorway to the outside is to the left. A new set of stairs is proposed directly ahead, the staff restrooms in the curtain area ahead and the caterer's kitchen around the corner. The door to the right leads to the current restroom for the building. This should be renovated to a bridal/event room.**

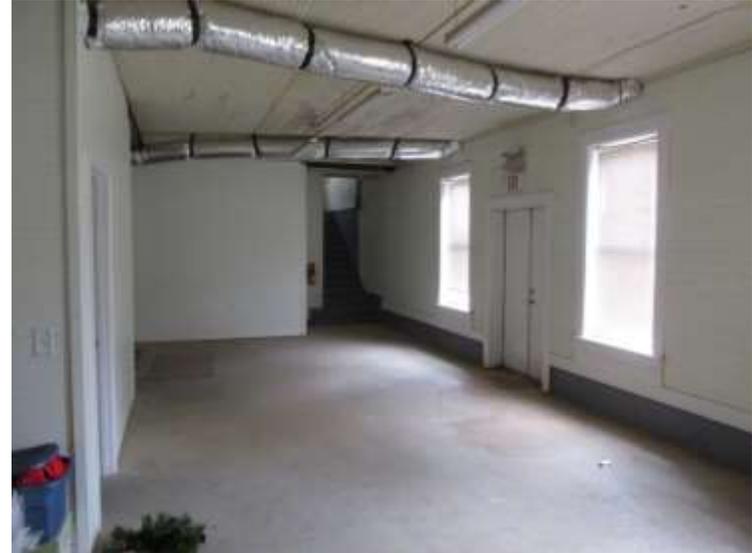
**Figure 35. Lower level looking towards current stairs to the main floor. The doorway to the left leads to the current bathroom/proposed bridal/event room. Straight ahead the area can be utilized as an office for the Building Manager once the current stairs are walled off. The doorway to the right leads to the outside and proposed road extension from North Hazel Avenue.**

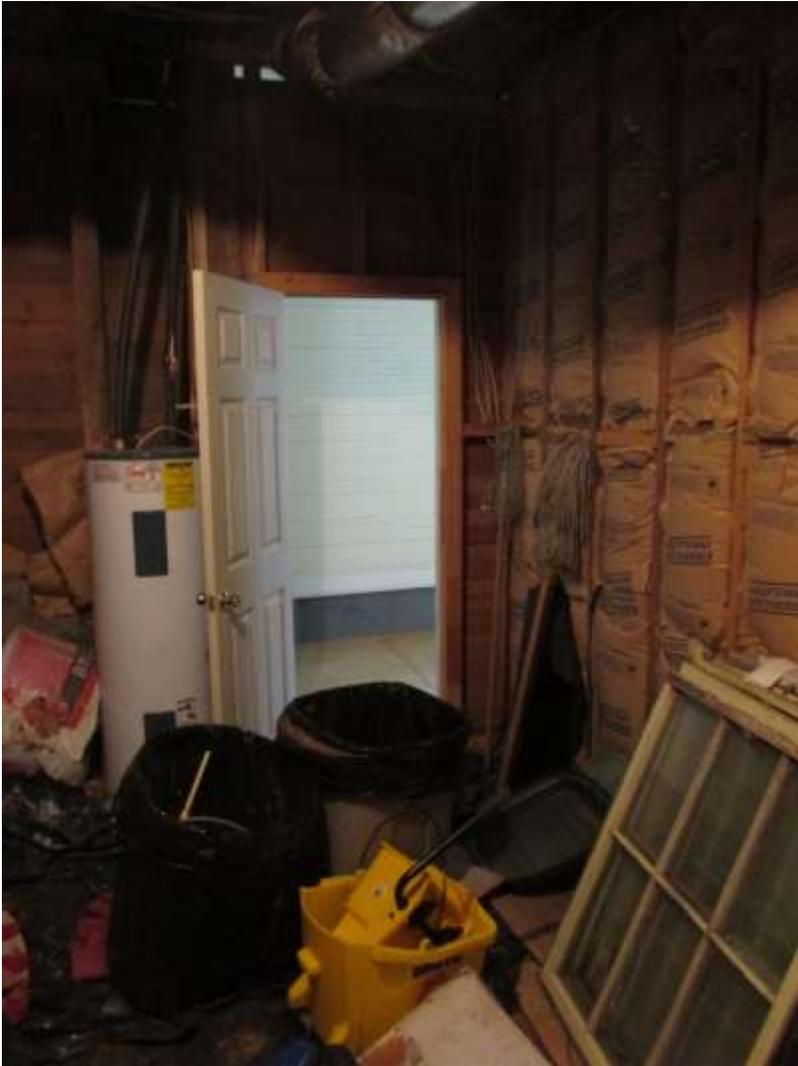
**Figure 38. Mechanical room with HVAC, electrical and plumbing systems. This room currently has some of the old wood sash windows that could be reused for the project.**

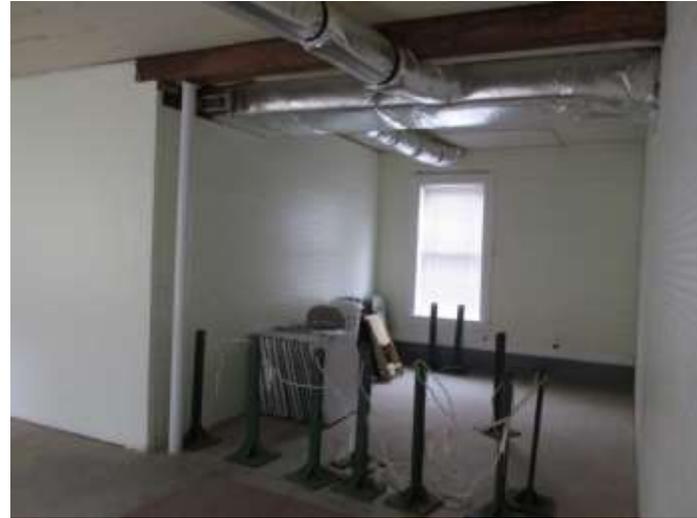
**Figure 39. Open area next to the restroom. This area should be incorporated into the new bridal/event room.**

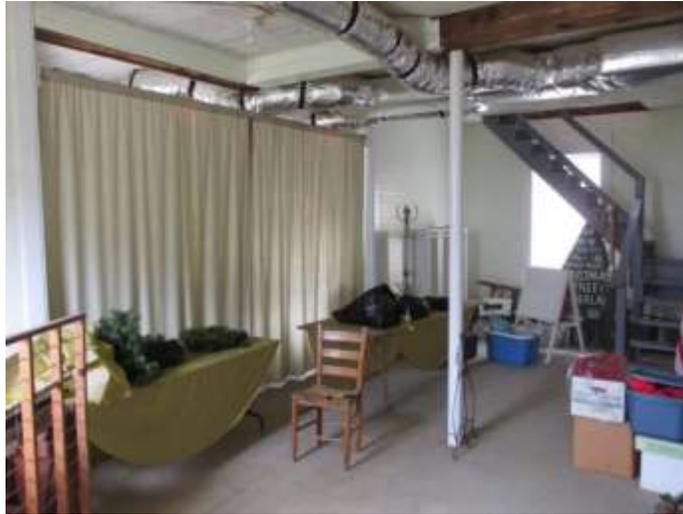
**Figure 41.** Lower level where the proposed caterer's kitchen could be relocated once the current stairs are replaced by the dumbwaiter system.

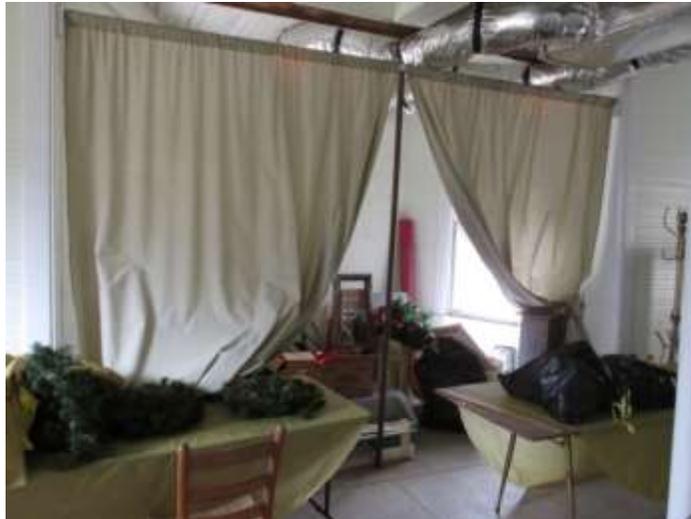
**Figure 42.** Lower level bay window area where the proposed staff restrooms should be located.
